**Second  
International Conference  
on  
Case Histories in  
Geotechnical Engineering**

**June 1-5, 1988**

**University of Missouri-Rolla  
Rolla, Missouri**

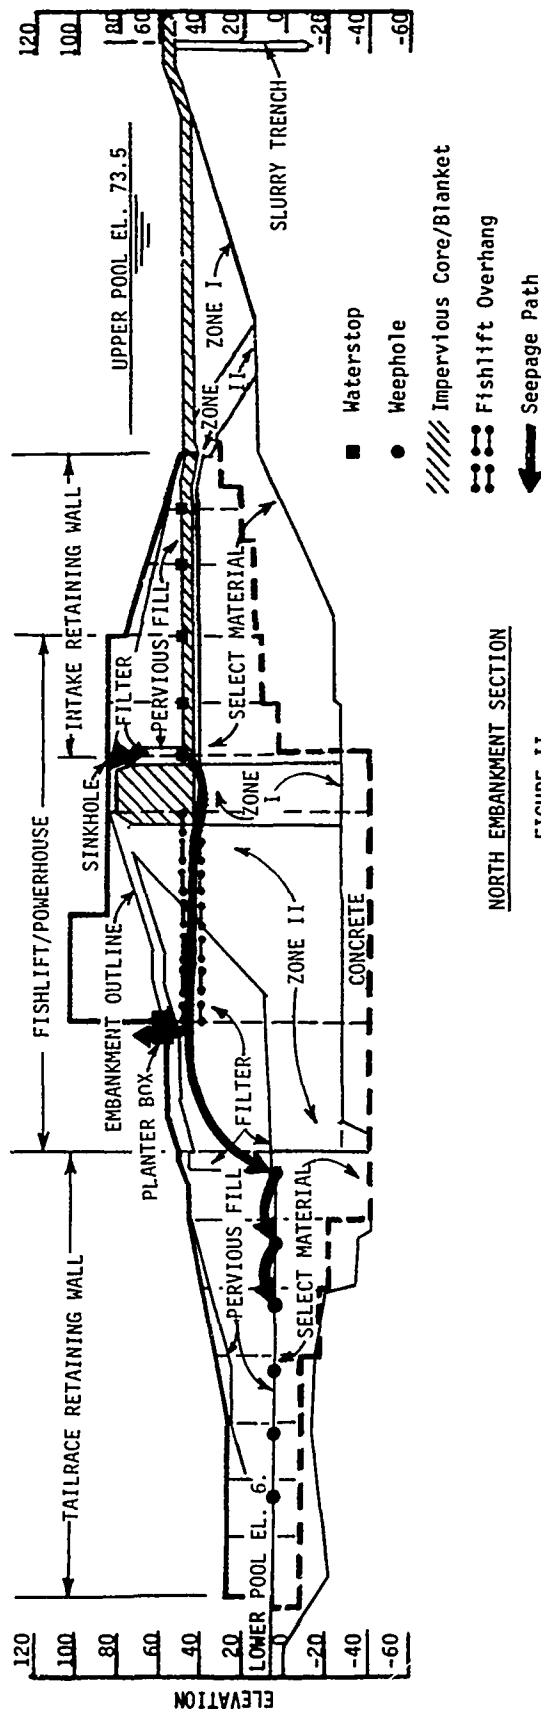
FIGURE II

NORTH EMBANKMENT SECTION

The excavation revealed that the path of the seepage flow began through and around the waterstop located in the monolith joint between the upstream retaining wall and the powerhouse (reference Figure II). This waterstop was added as a part of the VECP. The monolith joint is 16 feet upstream of the centerline of the embankment at the approximate contact of the core and the upstream filter. The flow breached the upstream impervious blanket at the waterstop and caused the development of a sinkhole in the embankment above the lake level. There were numerous deficiencies associated with both the design and construction of the waterstop. The flow traveled through the joint and into the select fill (pervious crushed rock) beneath the upstream impervious blanket. This allowed full reservoir head to act on the silty and clayey sands of the zone I fill immediately beneath the impervious core

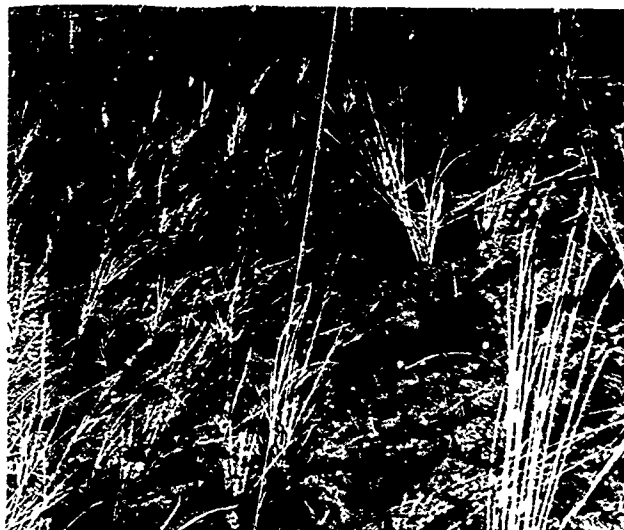
Fig. 3: Growth of Vegetation on the hill slope.

seeded and sprigged vegetation (Fig.3) forms a turf covering the hill slope and serves to protect the slope from subsequent erosion.

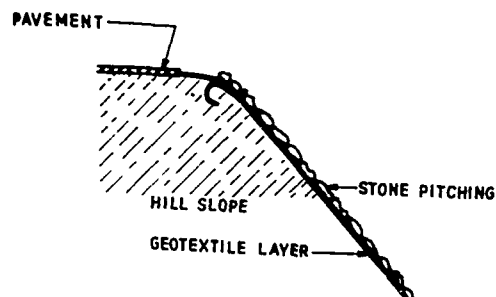
Fig. 5 : Protection of Hill Slope by Stone Apron

Erosion control on the hill slope can also be achieved by

providing a stone apron on the soil slope to be protected.

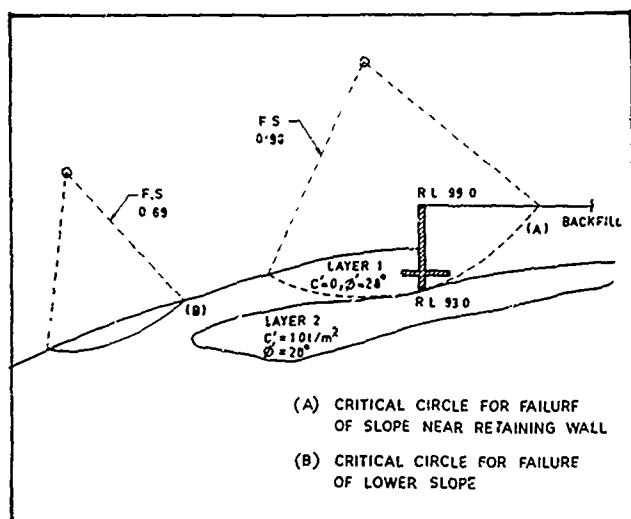
Fig.2, Soil Stratification and location of Critical Failure Surfaces.

Fig.2. shows the stratification of soil in this area. A relatively softer pocket of soil was found to be present in the slope area TU.

These results clearly bring out that the stability of the slope is highly sensitive to changes in piezometric level and a rapid increase in the factor of safety occurs when the water level goes down. The slope is likely to fail when the water table is at RL 99.0m i.e. at the top of the fill. As shown the critical failure surface is located just below the retaining wall and is tangential to the softer layer found in the region.

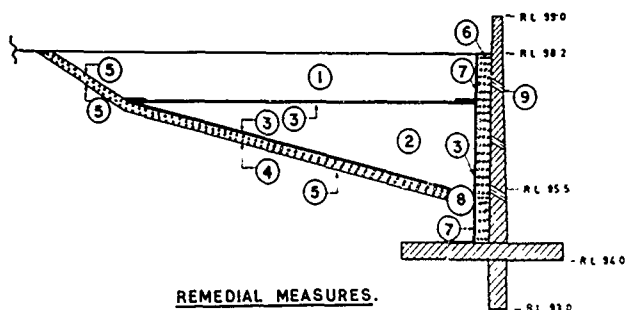
In order to keep the piezometric level low in the fill area inspite of long and sustained duration of rain storms, two rubble drains, one inclined and the second vertical are provided as shown in Fig. 3. The rubble drains are covered with permeable geotextile layer that would serve as a separation barrier. These drains are located such that they nearly form the boundary of the mass susceptible to failure. Thus the mass is kept in a well drained condition, thereby limiting the driving forces to a minimum.

1. 1m SOIL FILL.
2. COMPACTED SAW DUST ENCAPSULATED IN IMPERMEABLE GEOMEMBRANE. (2 LAYERS PVC SHEETING)
3. IMPERMEABLE PVC SHEET OR GEOMEMBRANE.
- 4, 6. RUBBLE FILTER DRAINS.
- 5, 7. PERMEABLE GEOTEXTILE.
8. COLLECTOR DRAIN WITH LONGITUDINAL SLOPE TO THE NATURAL NALLA.
9. WEEPHOLES.

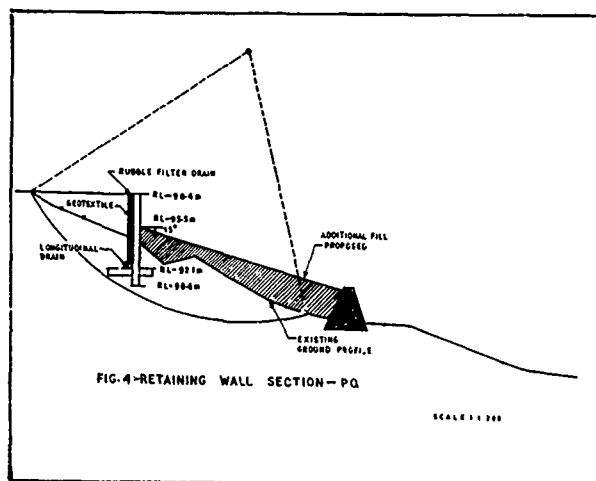
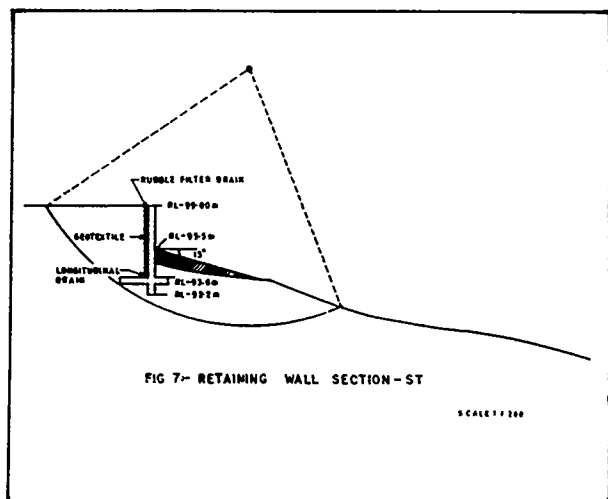
Stability analysis was carried out for the rest four sections viz. PQ, QR, RS, ST as well. The slope profiles are shown in Figs. 4,5,6 and 7. The factor of safety of these slope areas assuming piezometric level to be at RL 99.0m are

Stability analysis have clearly shown that the slope is liable to fail when the backfill is fully saturated i.e. with piezometric level at the top of the fill. Simple and inexpensive method of improving the stability of slopes by regulating the height of backfill has been considered the most feasible

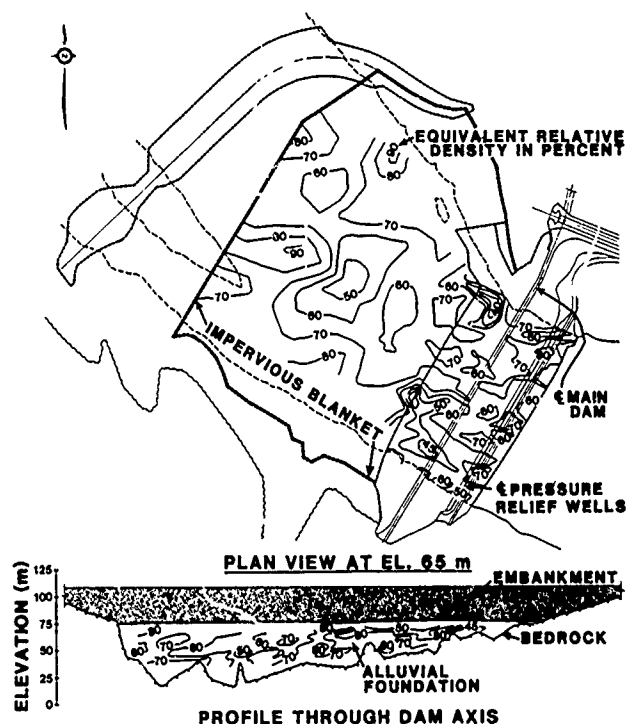
Fig. 1 Relative Density Contours

The densities of the river sands throughout the foundation for the Main Dam and the adjoining upstream and downstream areas were established by standard, dynamic and static cone penetration tests. Fig. 1 shows some typical contours of equivalent relative density in plan at el. 65 m and in section along the centreline of the Main Dam.

It was evident from these results that the densities vary appreciably in both the vertical and horizontal directions. These variation densities indicated that differences in compressibility might exist, which could result in unacceptable differential settlement.

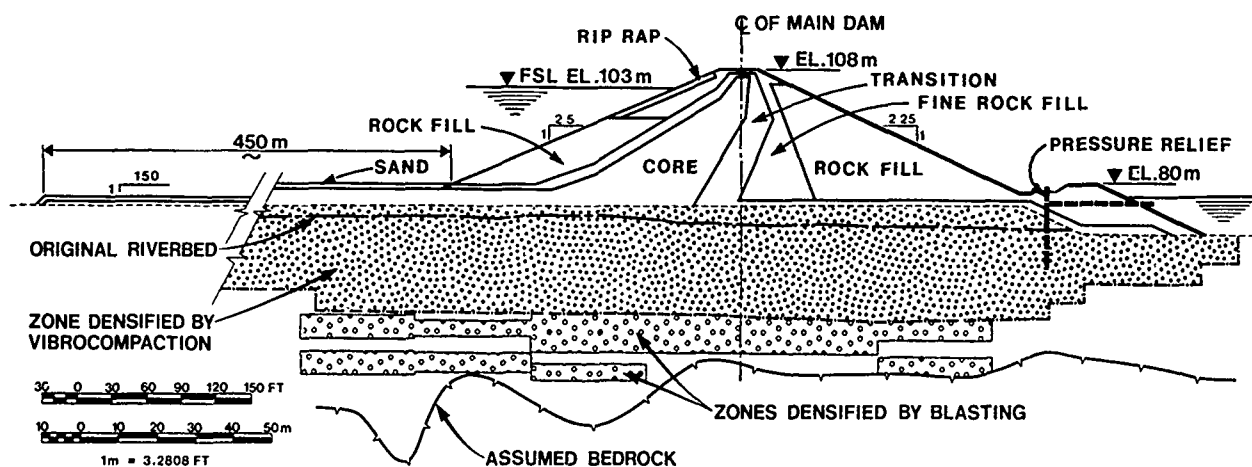
Fig. 2 Main Dam Cross Section

of the blanket to prevent any such occurrence. To achieve desired densities, the Contract specified that compaction below 25 m would be done by blasting and the top 25 m compacted by vibrocompaction (Fig. 2). Details of the densification program are presented elsewhere (Solymar et al 1984a, Solymar 1984b and Mitchell 1986).

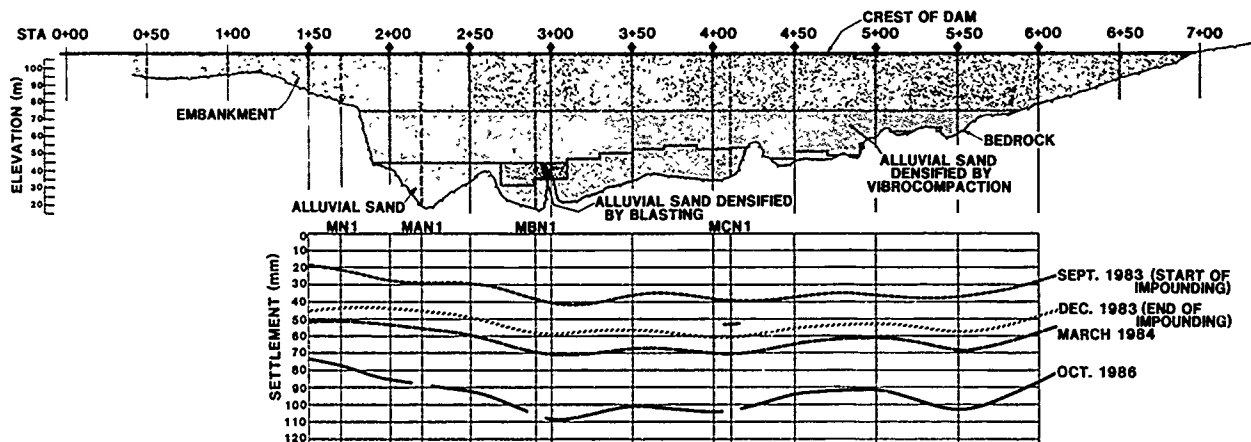
Fig. 5 Settlement of the Crest

Settlements in the foundation have been very much as anticipated. The maximum settlement recorded during construction was 160 mm. Construction of the embankment resulted in a compression of 0.19 to 0.27% of the alluvial foundation. The impounding of the reservoir resulted in an additional maximum compression of 0.04%. Compression of the foundation with depth was fairly uniform, indicating that the densification program achieved its aim. The surface and embankment settlements are less than those predicted by the finite element analysis, except in the transition zones. The largest differential settlement within the core is 30 mm and occurred between Sections MN and MA and the largest differential strain is 0.06 percent. These are half of the predicted values (Fig. 5).

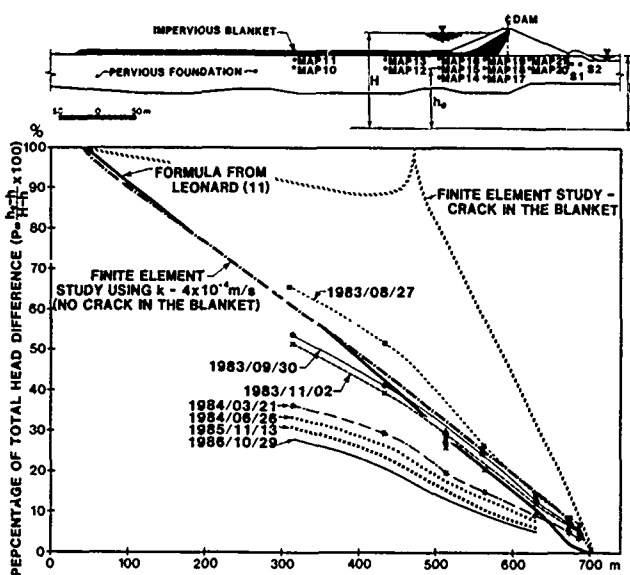
Fig. 7 Comparison Between Calculated and Observed Potentials

A comparison between theoretical and observed potentials with time are shown in Fig. 7. Generally, at the beginning, piezometric levels followed the head difference between reservoir level and tail water. At approximately 8 m head differential the piezometric levels started to lag. A further sharp reduction in potential occurred just prior to completion of the impounding. The change in potential indicates extension of the blanket by natural siltation or reduction of permeability due to filtration of silt into the sand foundation. The result is the same. In effect, the length of the blanket was extended by approximately 150 percent or the average coefficient of permeability reduced by the same percentage.

This phenomenon can be explained by observing the difference in clarity of the water between the reservoir and the discharge from the downstream relief wells. The water in the reservoir is loaded with fine, clay size soil particles while the discharge from the relief wells is clear. The sand foundation under the dam works as a filter and the clay size particles become trapped in the pores between sand grains. Gradually the pores are filled and the permeability is reduced. The net effects are reduced pressure under the blanket and reduced seepage.

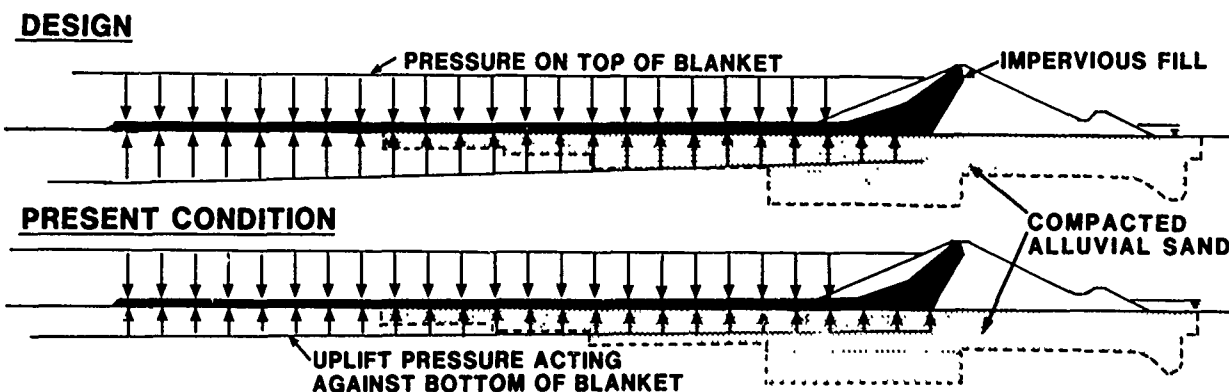
Fig. 8 Pressure Acting on the Impervious Blanket and Depth of Compaction

The piezometric head can also be plotted directly (Fig. 8). The latest readings again indicate lower pore pressures in the foundation than those assumed in the design. The pressure above the blanket equals that of a full reservoir and, since the pressure underneath the blanket is much smaller the resulting differential pressure will cause some settlement of the blanket. Where the differential pressure is greatest, near the upstream toe of the dam, the foundation was compacted to the same depth as underneath the dam. Therefore differential settlement or cracking of the blanket is not expected to occur and piezometer readings would immediately detect any such cracking.

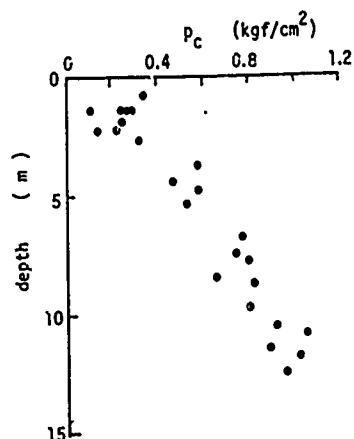
Figure 3 Variation of preconsolidation pressure in relation to depth

The undisturbed samples of peat and silty clay were obtained by the thin-wall piston sampler before the embankment construction. Figure 3 shows the variation of the preconsolidation pressure  $p_c$  in relation to depth.

It is observed from Figure 3 that the preconsolidation pressure  $p_c$  of the peat is in the range between 0.1 and 0.35 kgf/cm<sup>2</sup> and the average value is 0.25 kgf/cm<sup>2</sup>. The value is considerably larger than the effective overburden pressure and it is noticed that the peat layer is overconsolidated. The overconsolidation of surface layer in this case is attributed to desiccation. The preconsolidation pressure  $p_c$  of the silty clay is in the range between 0.32 and 1.05 kgf/cm<sup>2</sup>. In the silty clay layer,  $p_c$  is also considerably larger than the effective overburden pressure.

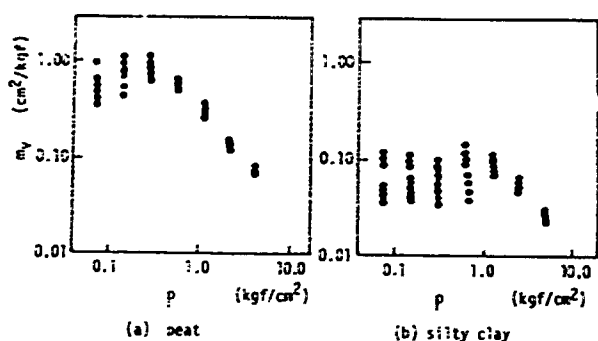
Figure 4 Relationships between volume compressibility  $m_v$  and consolidation pressure  $p$

The relationships between the coefficient of volume compressibility  $m_v$  and the consolidation pressure  $p$  were shown in Figure 4. It is found that the relationships are almost linear for values beyond the preconsolidation

pressure. Figure 5 shows the relationships between the coefficient of consolidation  $c_v$  and the consolidation pressure  $p$ . The final settlement and the time-settlement relation was calculated by using the results shown in Figures 4 and 5.

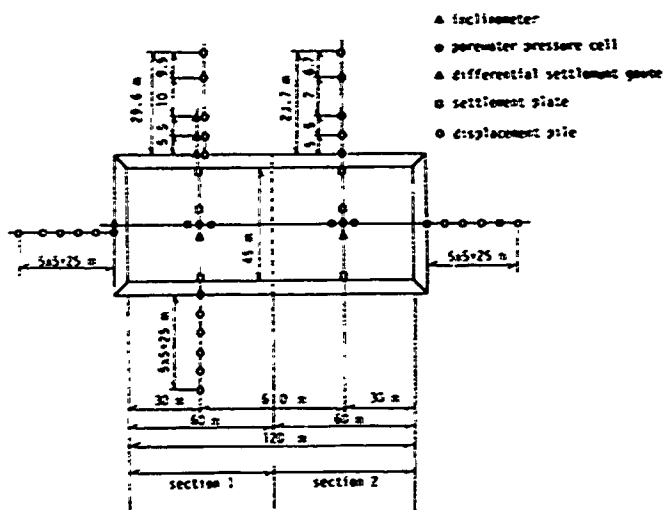
Figure 6 Plane of embankment and arrangement of instruments

The plan of the low test embankment was shown in Figure 6. The gauge arrangement was also shown in Figure 6. The embankment can be divided into two sections. In this study, the section of left hand side in Figure 6 is called section 1. In the section 1, the sand mat with 50 cm thick was laid between the ground surface and the bottom of fill. The section of right hand side in Figure 6 is called section 2 and the sand mat was not laid in the section 2.

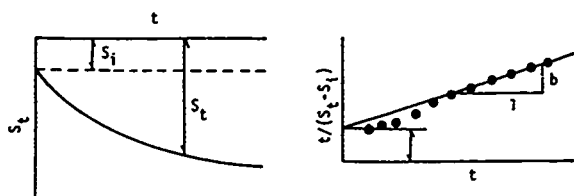
Figure 7 Schematically representation of hyperbolic curve method

The hyperbolic curve method is based on the assumption that the rate of settlement is represented by a hyperbolic curve. It is assumed that the relationship between settlement  $S$  and time  $t$  is schematically represented by a hyperbolic curve as shown in Figure 7(a).

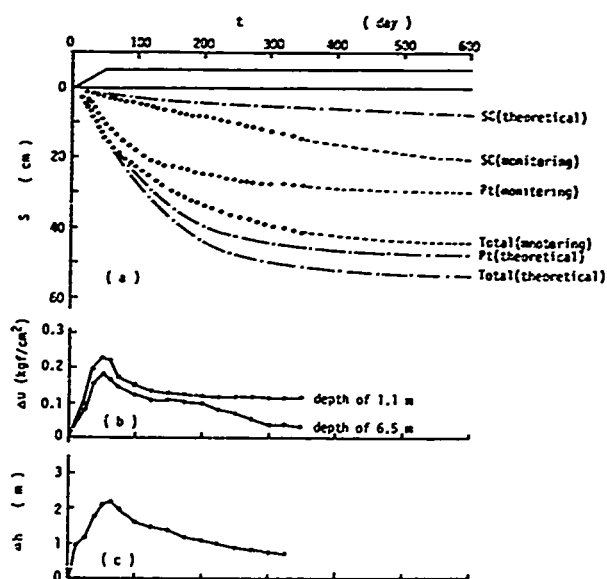
Figure 8 Settlement  $S$ , porewater pressure  $\Delta u$  and groundwater level  $\Delta h$  at center in section 1

The results of settlement observations were shown in Figures 8 (a) and 9(a). The relationships between  $t$  and  $t/(S_t - S_i)$  are plotted in Figures 10 and 11.

To simplify the calculation of rate of consolidation for the multi-layered foundation, the two strata were converted to a single stratum by the method previously proposed [Palmer et al, 1957]. Figures 8(a) and 9(a) show the comparisons between the observed and predicted settlements. For the SC layers, the observed settlements are far larger than predicted ones. On the other hand, for the Pt layers, the predicted settlements are larger than observed ones.

The variation of the porewater pressure  $\Delta u$  in the Pt and SC layers under the center of the sections 1 and 2 are shown in Figures 8(a) and 9(b). It is seen that the maximum porewater pressure occurs at the end of construction and the values are from 0.19 to 0.29  $\text{kgf/cm}^2$ . On the other hand, the increment load by the embankment is 0.35  $\text{kgf/cm}^2$ . The maximum porewater pressure occurred in foundation deposits are smaller than the increment load. For both the sections 1 and 2, the dispersion of porewater pressure in SC layer is faster than it in Pt layer. The maximum porewater pressure in the section 1 is smaller than it in the section 2 due to the effect of the sand mat.

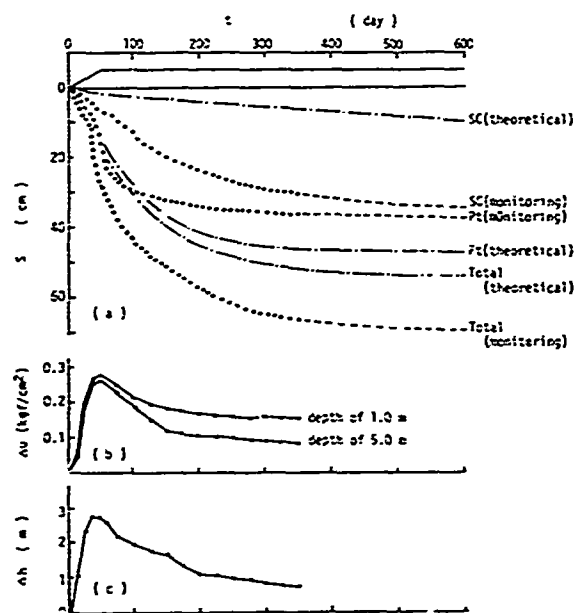
Figure 9 Settlement  $S$ , porewater pressure  $\Delta u$  and groundwater level  $\Delta h$  at center in section 2

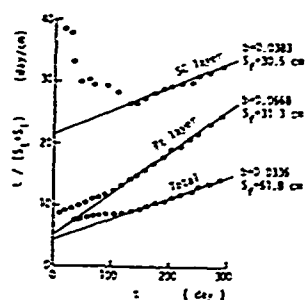
Figure 10 Prediction of settlement by hyperbolic curve method (section 1)

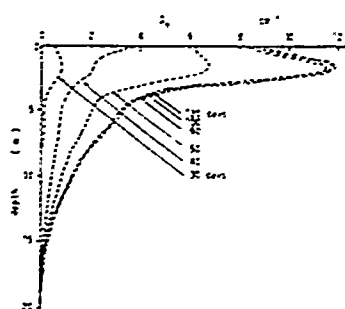
Figure 12 Horizontal displacement  $U_h$  at toe of embankment (section 1)

Figures 12 and 13 show the horizontal movements measured by the inclinometer located at the foot of the slope edge

and 5 m away from it in the section 1 respectively. At the end of the measurements, the maximum displacement measured was about 12 cm at the toe of slope and about 5 cm at 5 m away from it. It is noted that the horizontal displacement is considerably small.

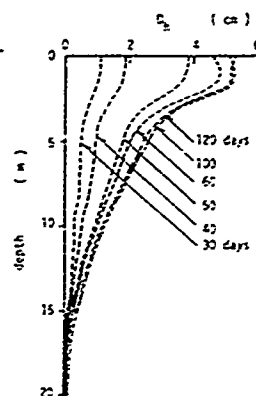
Figure 13 Horizontal displacement  $U_h$  at 5 m away from toe of embankment (section 1)

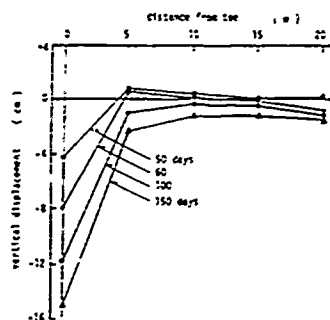
Figure 14 Vertical displacement at from toe of embankment to 20 m (section 1)

Figure 14 shows the vertical movements measured by the displacement piles located at from the foot of the slope edge to 23 m away it in the section 1. At the toe of the slope, a considerable settlement occurred, but the vertical displacement do not nearly occurred at from 5 m to 20 m away it.

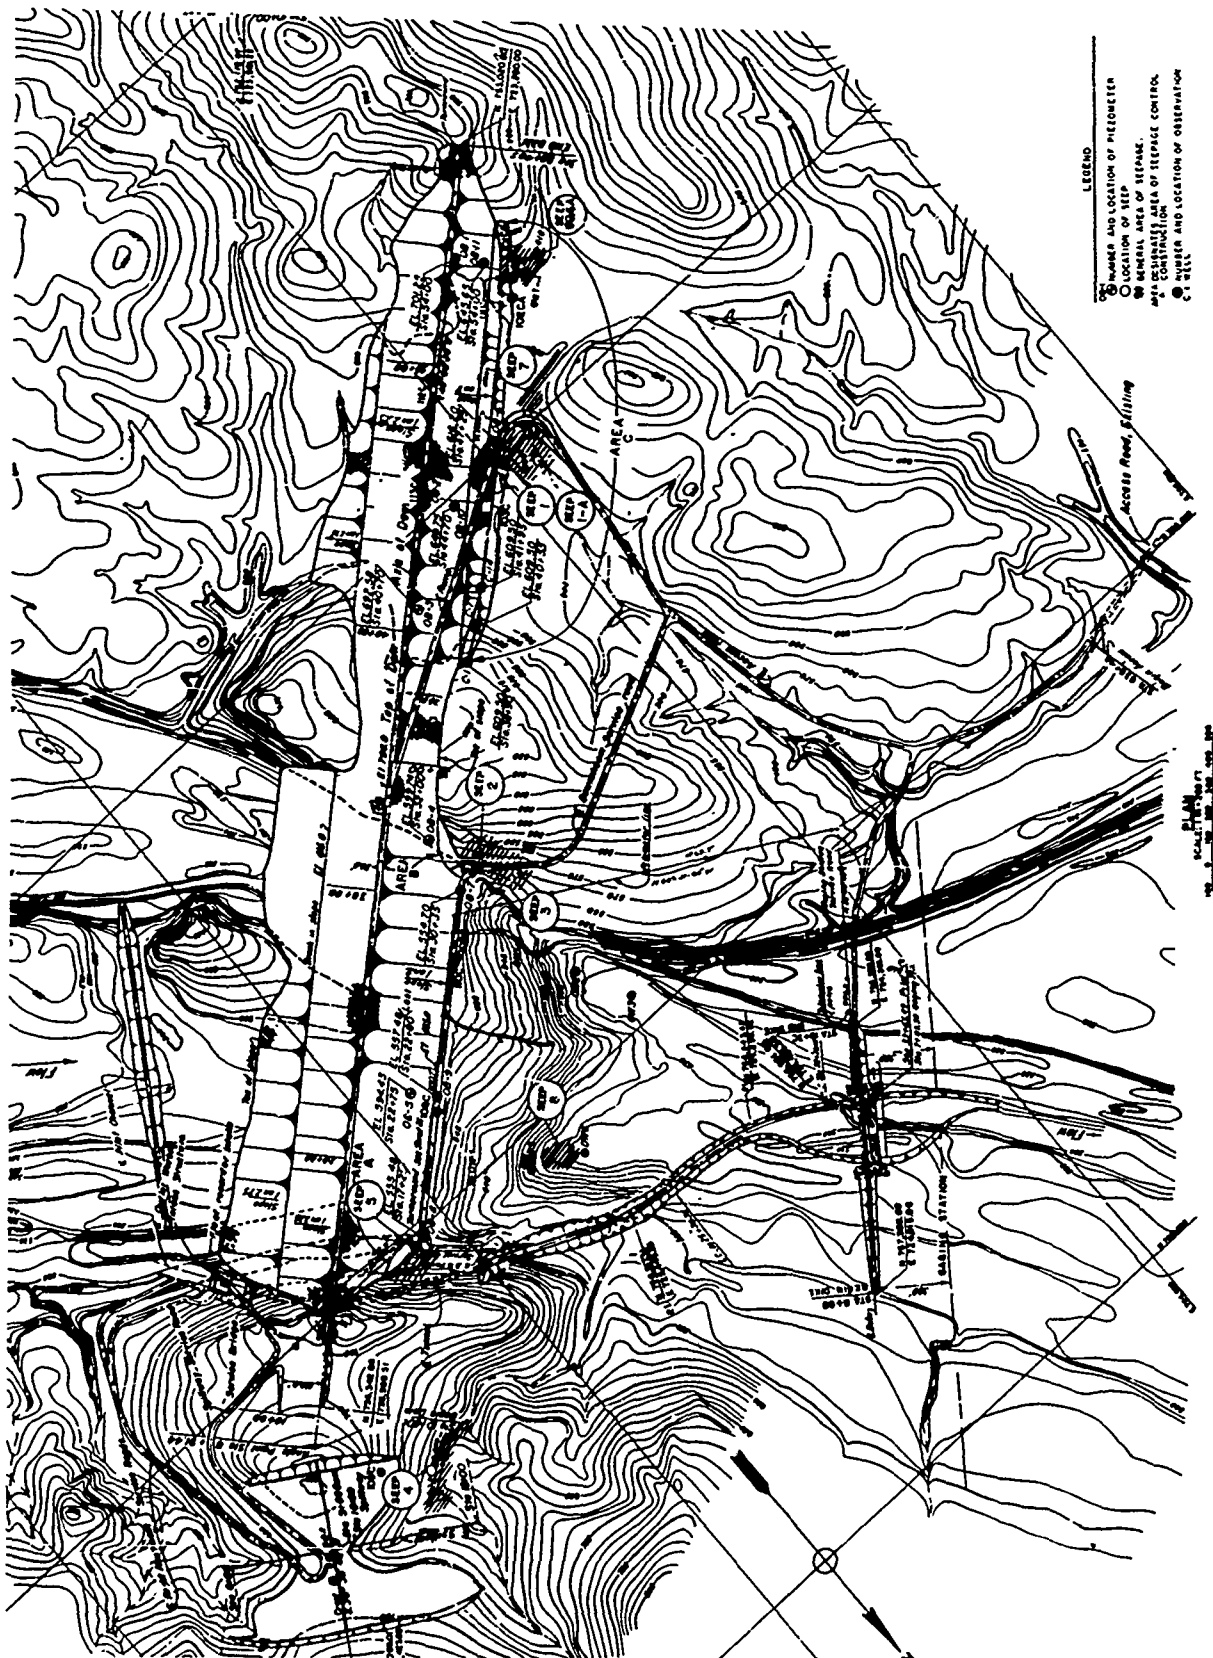
Figure 4. Plan view of Painted Rock Dam showing sequentially numbered seeps in their order of occurrence.

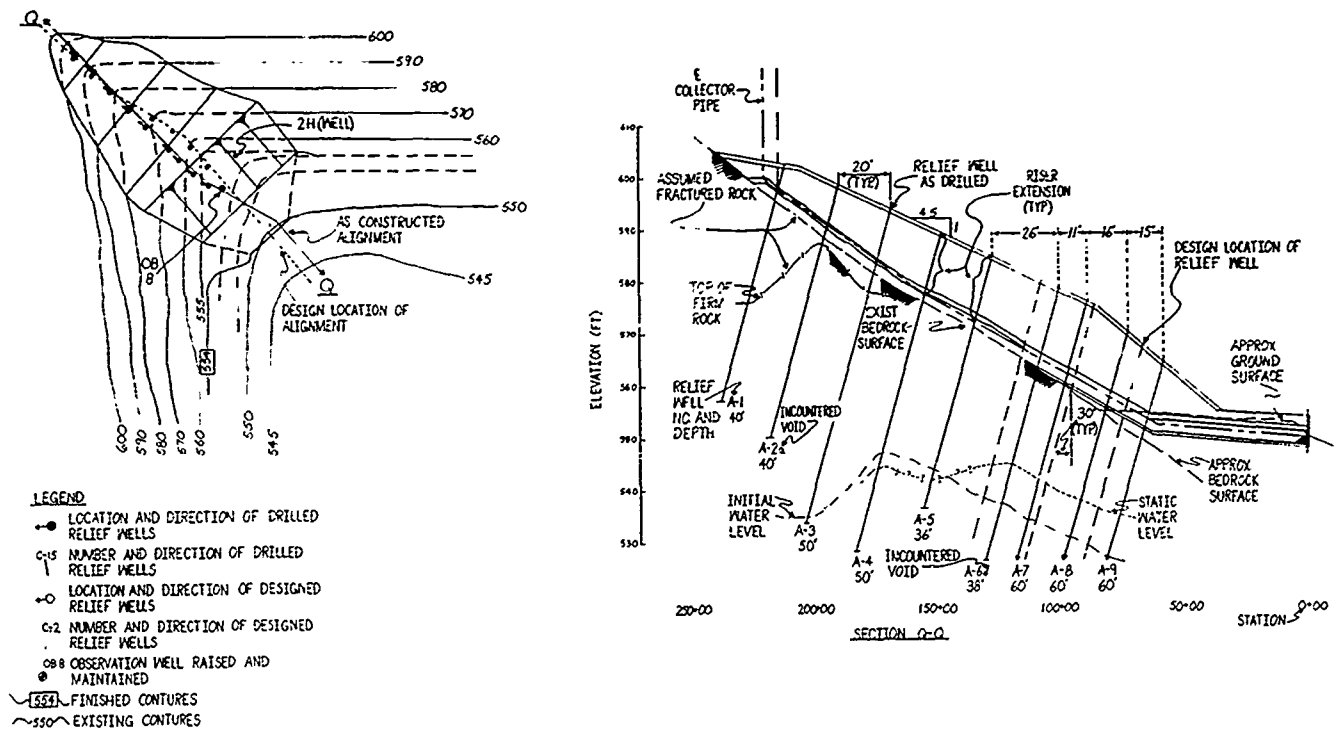
Figure 7. Plan and section of seepage control systems and stability berm constructed in Areas A and B.

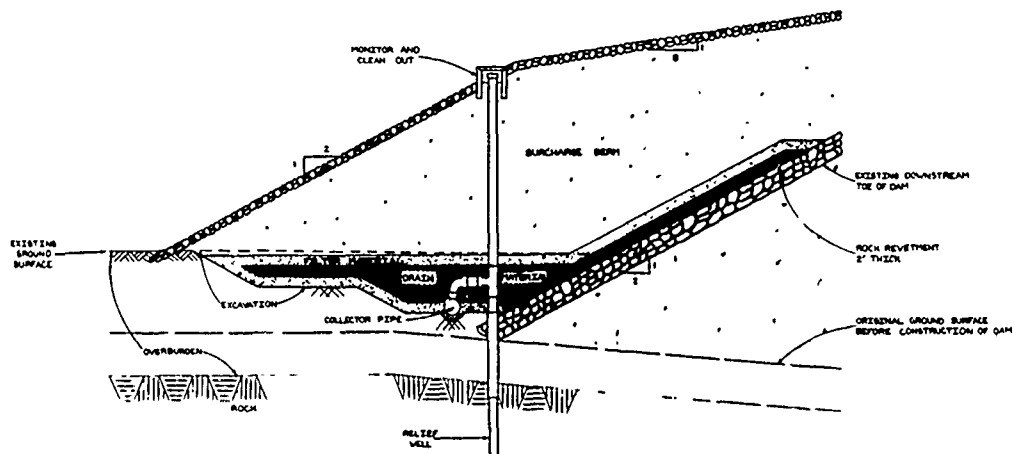
Figure 8. Section of seepage control systems and stability berm construction in Area C.

Area C extends from Sta 40+00 to 54+70 and contains Seeps 1 and 6. It was considered the most critical area due to the shallowness of the foundation alluvium and a contained basin in the rock surface at depth. Four gravel packed relief well systems were installed in this area, totaling 40 wells drilled 40 ft (12.2 m) into rock at 20 ft (6 m) spacing. Wells were deleted when the alluvium exceeded the 15 to 20 ft (4.6 to 6 m) depth. Discharge from each group of wells was routed into a manhole which contains silt basins and provisions for measuring flow quantities. From the manholes the flow is routed to a headwall for discharge. The area was covered with a drainage blanket and stability berm extending onto the embankment, Figure 8.

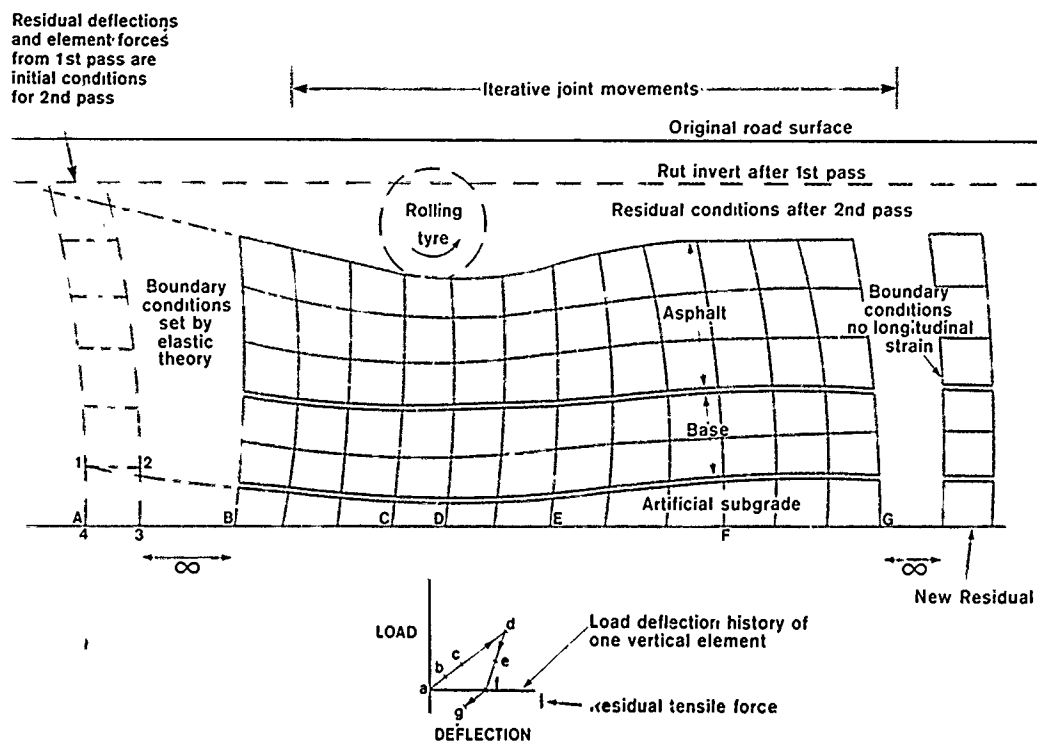
Fig. 1 Diagrammatic Longitudinal Section of the Three Dimensional Pavement Analysis Showing Boundary Conditions, and Computational Process (after Smith and Yandell, 1986a)

A longitudinal section of a mechano-lattice simulation of a pavement is given in Fig. 1. The hysteresis loop at the bottom of the figure was formed by plotting sequential load-deflection values through positions A,B,C,D,E,F and G of a vertical element in one particular unit. A similar but more complex task is performed by the computer after each cycle of element length-load calculations. The forces at each joint are resolved into vertical, longitudinal and lateral components, and the joint is then moved in a damped manner in the direction of the unbalanced forces. The calculation damping factor is proportional to the largest force that is instantaneously out of balance at any free joint. This process is continued until all out of balance forces at free joints become insignificant. This now generally occurs after around 400 computational cycles. After convergence, and after stresses have been calculated, the wall of units on the right of Fig. 1 is used to give the initial condition for the next simulation wheel pass. The above process is then repeated until a total of 32 load-deflection histories is followed for each mechano-lattice unit.

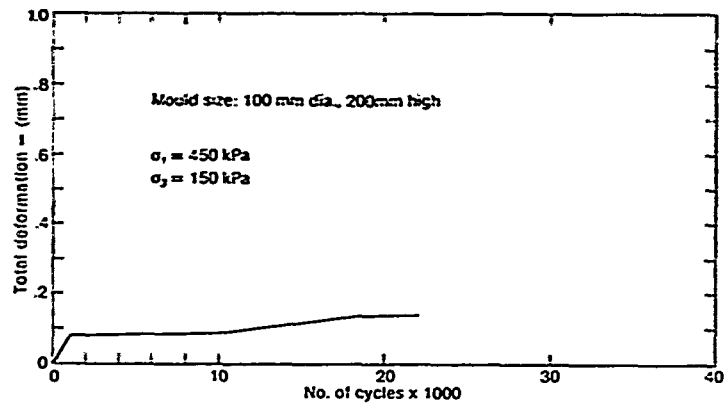
Fig. 2 Total Deformation versus Loading Cycles for Crushed Rock (after Smith and Yandell, 1986a)

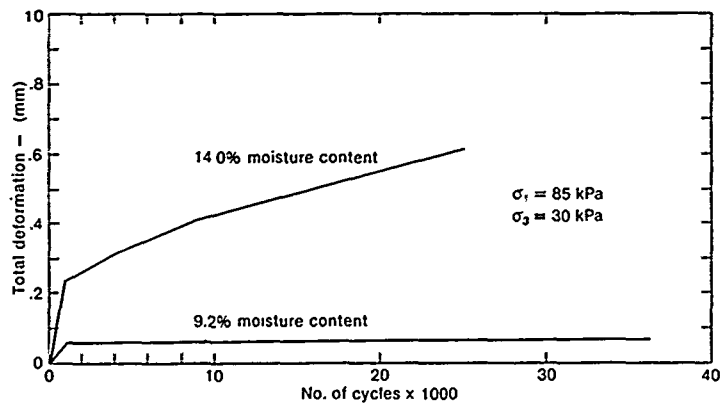
Fig. 3 Total Deformation versus Loading Cycles for Imported Subgrade (after Smith and Yandell, 1986a)

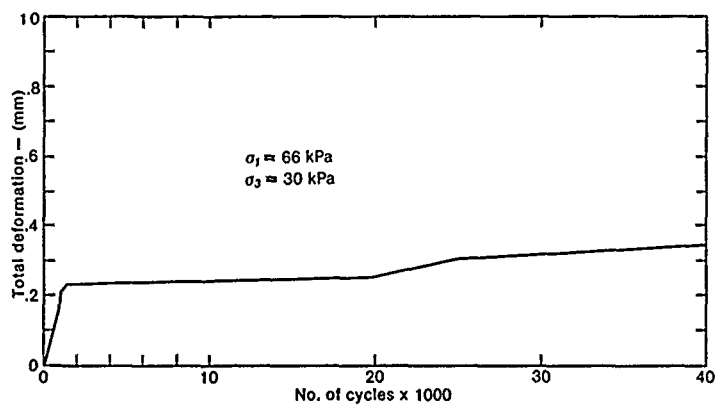
Fig. 4 Total Deformation versus Loading Cycles for Imported Subgrade (after Smith and Yandell, 1986a)

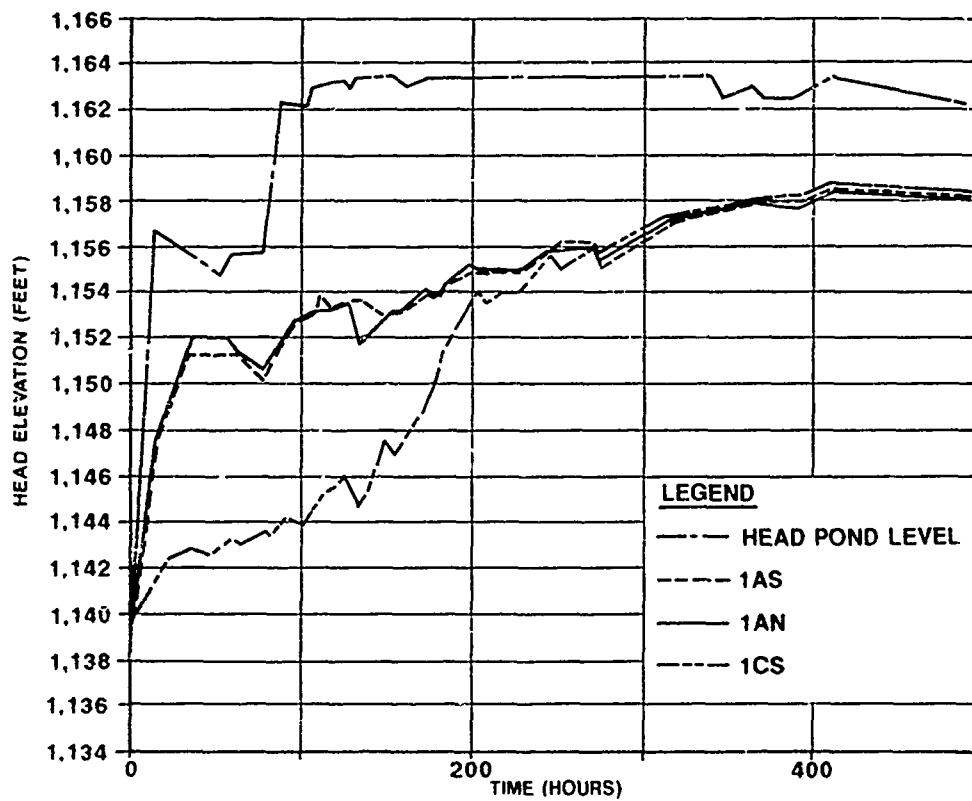
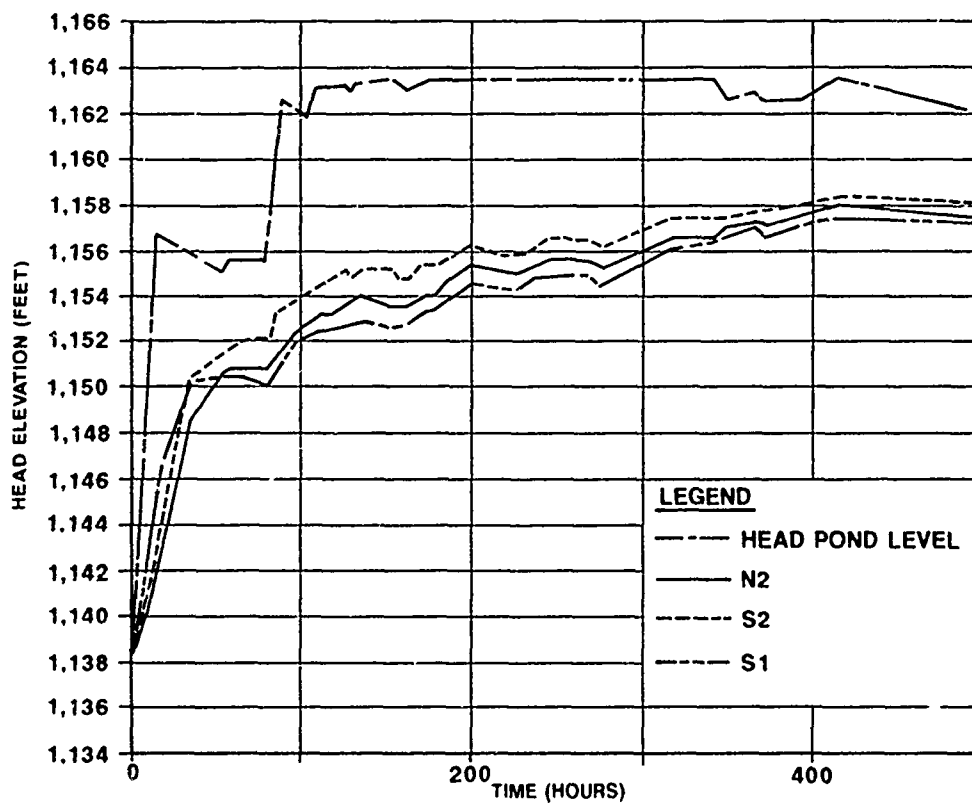
Fig. 2 Piezometer Response vs Head Pond Level  
After Final Seal Repair

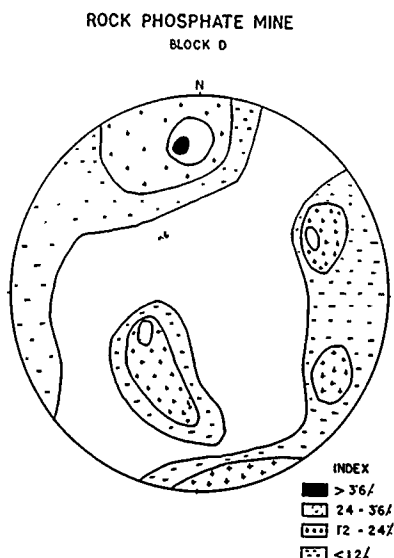
FIG 2 STEREOCONTOUR PLOT OF JOINT POLES

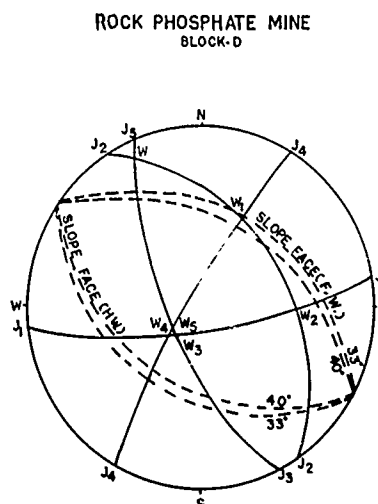
FIG 3 STEREO PLOT FOR THE ANALYSIS OF TYPE OF FAILURE

From Fig. 3 it is clear that total six wedges have been formed (W<sub>1</sub> to W<sub>6</sub>) with four joint sets, mentioned in table 1. The only wedge fulfilling the essential condition for the wedge failure is W<sub>1</sub>, i.e., it is unfavourably oriented in the slope, rest of the five wedges are favourably oriented in the slope and failure along them are unlikely.

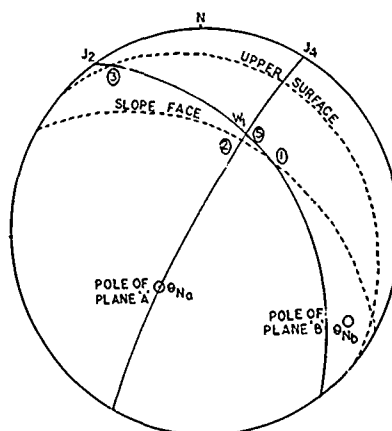
FIG 4-STEREOPLOT FOR THE ANALYSIS OF WEDGE FAILURE ALONG  $W_1$  WEDGE

Wedge failure analysis of W<sub>1</sub> wedge has been done separately (Fig. 4) and the calculation has been presented below.

Input data available from fig. 4 are -

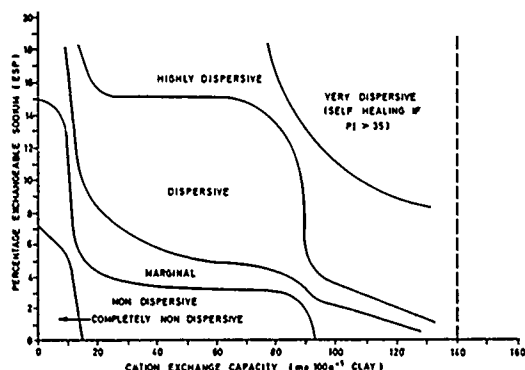
FIGURE 1. Diagram illustrating the influence of composition of the clay fraction as manifested in  $\text{CEC } 100\text{g}^{-1}$  of clay and ESP on dispersion (according to all four methods evaluated).

From figure 1 it is evident that variation

$\text{me } 100\text{g}^{-1}$  of clay were completely non-dispersive at ESP-values of 6 (Figure 1). Soils with high CEC-values and plasticity indices greater than 35 (PI), swell to such an extent that the influence of dispersion on the stability of structures are expected to be insignificant. This explains why these soils can be used for hydrosealing if judiciously placed. From the research it became evident that the results of the physical methods, namely the pinhole, double hydrometer, sticky point and crumb tests, will be invalid if the water quality is not considered, or if the soil solution contains soluble free salts. This is due to the influence of free salts in the soil and water on dispersion (Bolt and Bruggenwert, 1976) (Figure 2). The inability of these methods to identify dispersive soils unambiguously was proven in all instances where free salts were present, which is more often than not the case with sodium saturated natural soils (Gerber and Harmse., 1986).

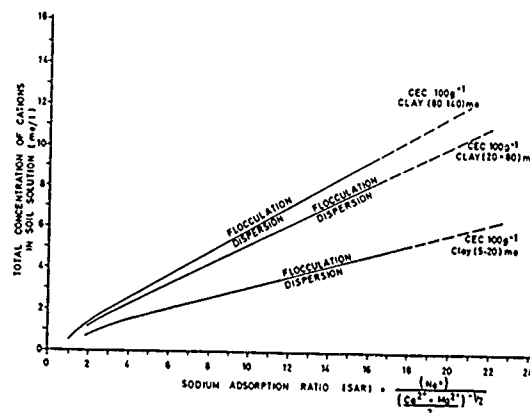
FIGURE 2. The influence of free salts with a high sodium content on flocculation and dispersion as influenced by the composition of the colloidal fraction of mineral soils.

Determination of CEC by the summation of extractable cations (Sherard, Dunningan and Decker, 1972) may lead to conflicting results. This method can be invalid if soluble salts occur in the soil solution or if the base saturation of the soil is less than 100 per cent. Application of the results represented in figures 1, 2 and 3 enables easy

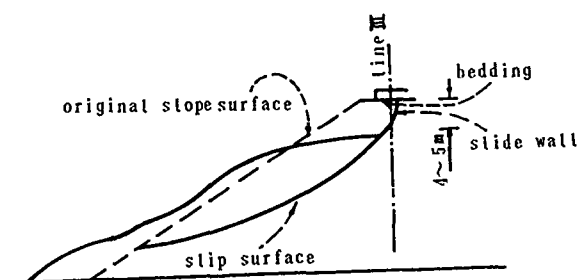
Figure 1

There are three sets of tracks on the embankment, which was completed in 1973. The upper approximately ten meters of the embankment at 1v:1.5h are steeper than the lower portion at 1v:1.75h. Transverse 2.5m wide stone-filled drains have been placed in the slope, spaced at approximately 8 meters. The drains are approximately 1.5 to 2.0m deep. Between them are arch-shaped drains. A retaining wall was constructed at the foot of the slope.

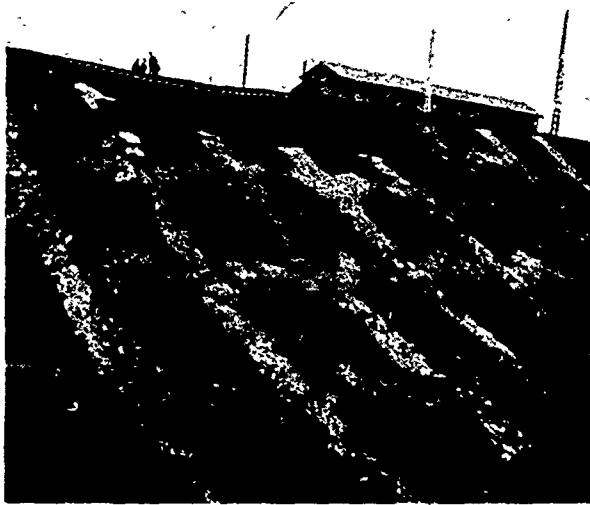
Figure 2

The rainy season in the region of the embankment is from July to September. On the 11th of October, 1980 a slide occurred on the slope of the embankment. See Fig. 2. The slide was about 50m wide, and about 4 to 5m thick. The slide scarp was about 0.3m on the 12th, 2.0m on the 19th, and was about 4 to 5m high by the 21st of October. The drains on the slope and the retaining wall at the foot of the slope were damaged, and the rails were suspended from their ends, due to the removal of support by the embankment.

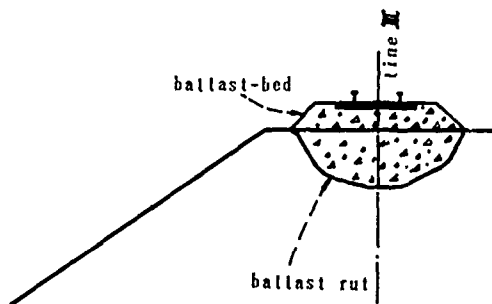
Figure 3

3. Water accumulation under the ballast bedding softened the embankment and allowed penetration of ballast into the bedding, causing a ballast pocket. See Fig. 3. In turn, this pocket became a reservoir for further accumulation of water and fed the water into the embankment.

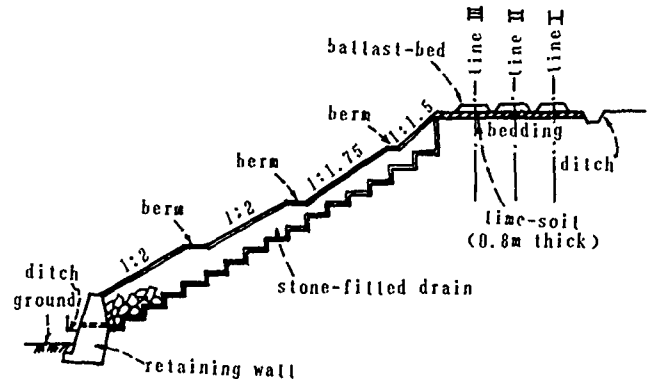
Figure 4

The main repair measures that were adopted are shown in Fig. 4.

1. A lime-soil mixture with a ratio of lime to sand to soil of 1:5:10 was used as a 0.8 meter thick bedding just below the ballast. A longitudinal ditch was set on the embankment to drain surface water.

2. After removing the slide materials, local expansive soil was mixed with 25% sand and recompact, with overall slope steepness reduced and three small berms introduced.

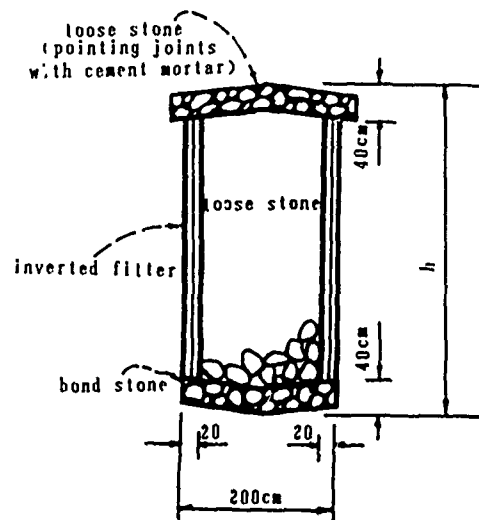
Figure 5

3. Nine transverse rock drains, 2m wide, and spaced 8m apart were built to extend one-half meter below the slip surface. Between the transverse drains, rock arch-drains were constructed. See Fig. 5.

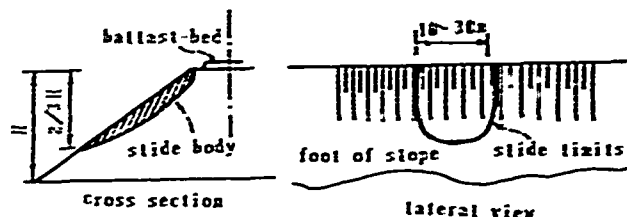
The failures appeared chiefly in the form of shallow slides. Generally these slides were limited to the top two-thirds of the embankment with a width of 10-30m and usually about 1 to 1.5m in thickness. Slide scarps were generally 1.0-1.5m in height. Fig. 8 shows details.

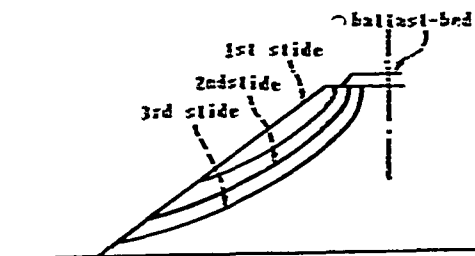
Fig. 9

As shown in Fig. 9, at some places the surface water caused successive shallow slides which eventually undermined the track at the top of the embankment.

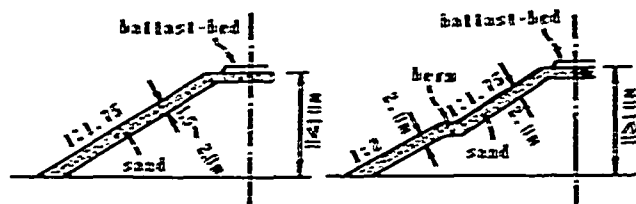
Fig. 10

For this embankment the repair was effected by placing sand on the surface of the embankment to a depth of 1.5-2m, as shown in Fig. 10.

1. The sand layer was designed to be 1.5m in thickness where the embankment was less than 10m high, and 2m in thickness for a higher embankment section. Under the ballast, sand was 1m thick.

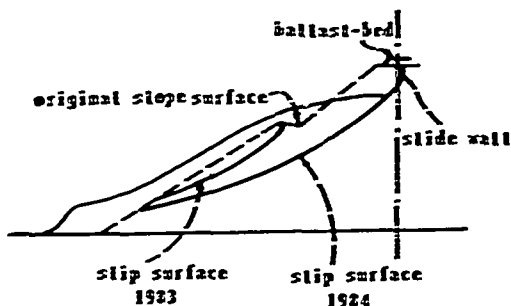
Figure 11

Three shallow layer slides occurred on the slopes in the rainy season of 1981. A large amount of surface water had seeped into the slope. Makeshift measures were taken to effect a quick repair; timber piles were driven through the slide and straw bags packed with soil were placed to be a counterweight for the slide. Each of the three shallow layer slides began to migrate upwards, so that the slide body became about 30m wide, 1.5-2m thick with slide scarps about 1.5m high. Fig. 11 depicts this.

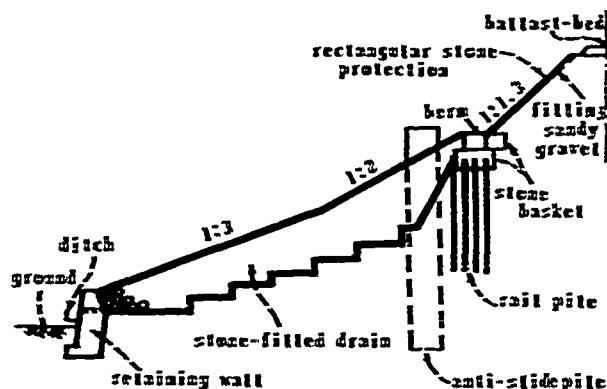
Fig. 12 shows the remedial measures taken to repair the slope.

1. The slope gradient was reduced. The upper 9m was 1v:1.3h, from 9 to 18m below the crest of the embankment, the slopes were 1v:2h, and all embankment below 18m was made with a 1v:3h slope. At the nine meter level a berm 2m wide was constructed. Two hundred twelve rail piles 12.5m long, at 1m spacing were driven below the berm. Reinforced stone baskets were placed on them. Just below the piles and stone basket on the slope were placed four large reinforced concrete anti-slide piles of 3.7m by 2.5m section 25m long.
